# High Performance Ball Joint

Walter Bordon  
 Marcus Zucchini  
 Gustavo Simião  
 Dana Industrial Ltda.

## ABSTRACT

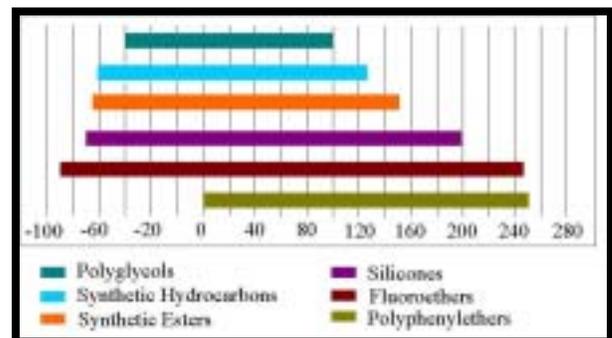
Figure 1: Working temperature of several lubricants (Degrees C)

Several lubricants were evaluated in order to achieve the desired effect. Figure 1 displays the working temperature range of several synthetic lubricant bases.

Based on the working temperatures, it was decided to test the silicone-based (Lubricant A) and the synthetic hydrocarbon-based (Lubricant B) lubricants. These results were compared to conventional mineral grease currently used in production.

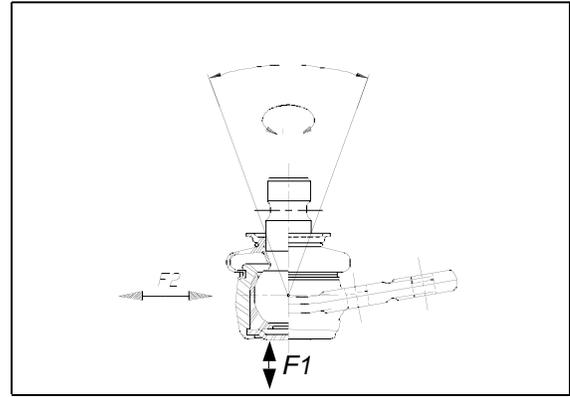
Figure 2: Ball and socket joint

The durability test was conducted with an axial load (F1) of  $0,2 \pm 1,0$  kN at a frequency of  $0,33 \pm 0,05$  Hz. A radial load (F2)  $2,0 \pm 5,0$  kN was also applied at a frequency of  $0,33 \pm 0,05$  Hz. The oscillation movements ( $\theta_1$ ) and rotation movements ( $\theta_2$ ) were of  $\pm 15$  degrees for both movements at frequencies of  $2,0 \pm 0,33$  Hz and  $0,5 \pm 0,1$  Hz respectively (Figure 2).

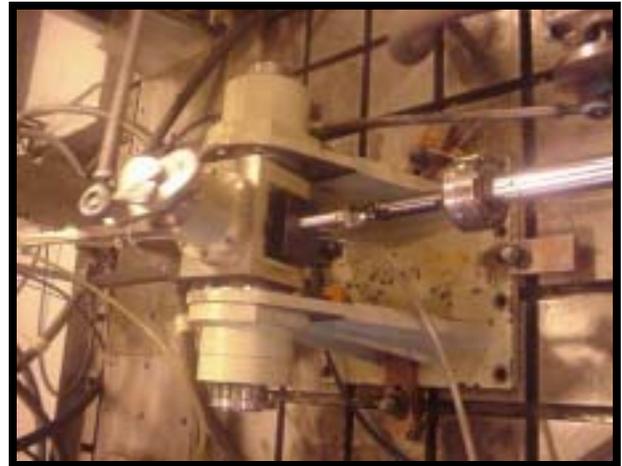
Figure 3: Test specimen in the test apparatus.

Figure 3 and Figure 4 display test specimens in the testing apparatus. Water was sprayed into the ball joints, which were removed from the protective seal (dust cover) in order to verify the resistance of the lubrication element to water.

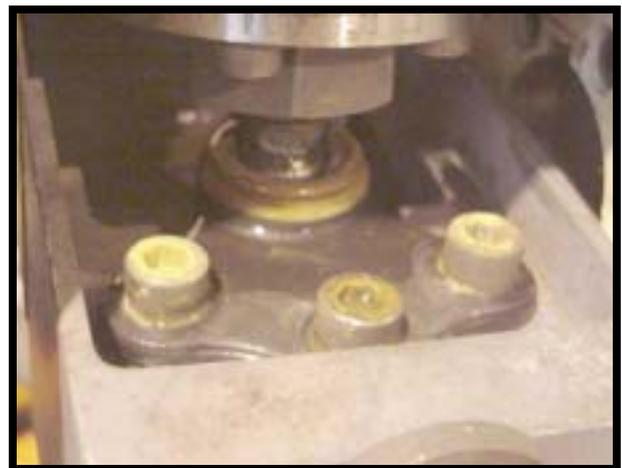
Figure 4: Test specimen in the test apparatus depicting the lack of the seal (dust cover)

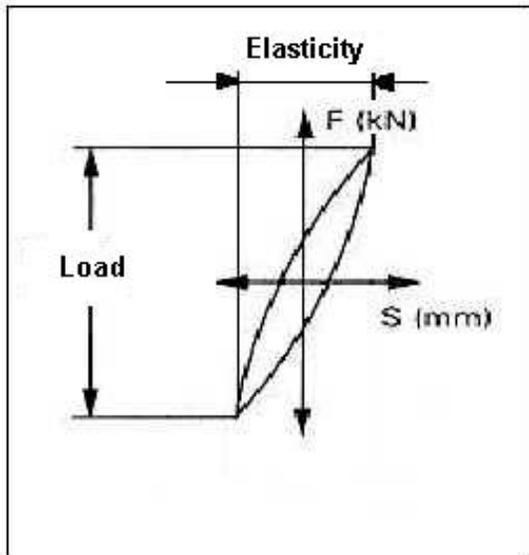
Figure 5: Elasticity measurement

The three lubricating constructions were tested. The test lasted 82,500 cycles of the radial load. The axial and radial elasticities of the test specimens were not to exceed 0.2 mm of their initial value before the test as displayed on Figure 5.

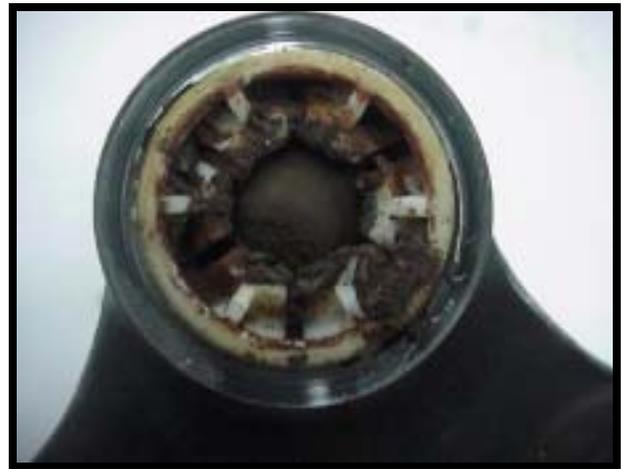
Figure 6: Remains of lubricant C on the bearing

The test specimens that used lubricating system 3 lost almost all of its lubricating element at the conclusion of the test as displayed of Figure 6 and Figure 7. This occurred due to the low resistance of this lubricating element to water.

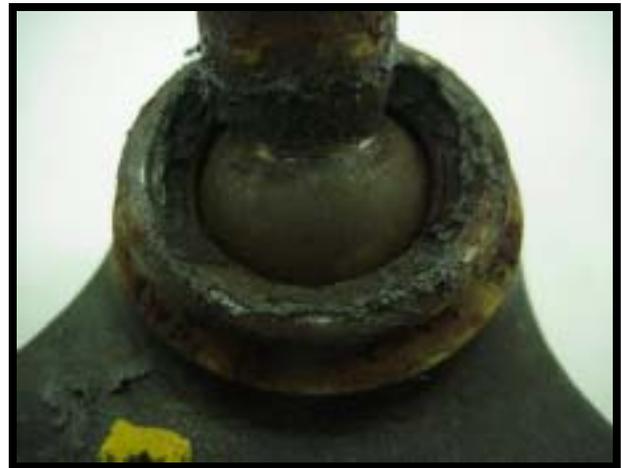
Figure 7: Loss of lubricant C on test specimen 05.

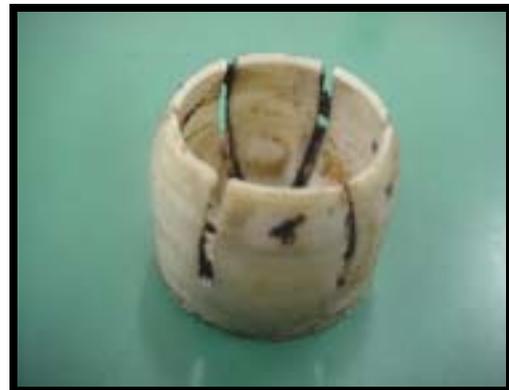
Figure 8: Plastic bearing of test specimen 02

After the disassembly of the ball joints that used lubricating system 3, it was verified that the plastic bearings did not present wear as displayed on Figure 8. This is a result of the correct selection of the bearing material that didn't display wear even though the lubricating element was washed out by the sprayed water.

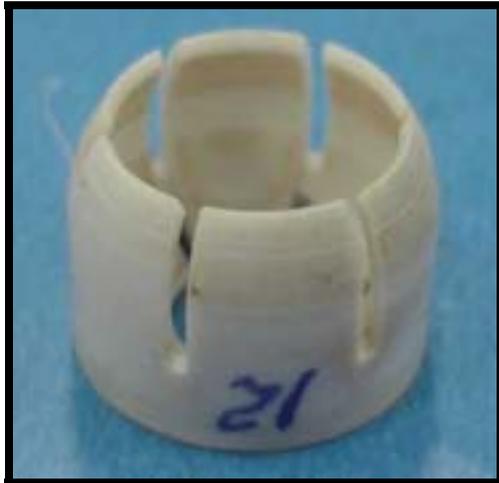
Figure 9: Plastic bearing A of test specimen 12

Lubricating system 1 obtained the best performance. The elasticity increase results were within the specification and there was no wear of the bearing as displayed in Figure 9. Figure 6 displays the lubricating element removed from the test specimen after the completion of the test demonstrating the resistance of this lubricating element to the conditions imposed by the test.

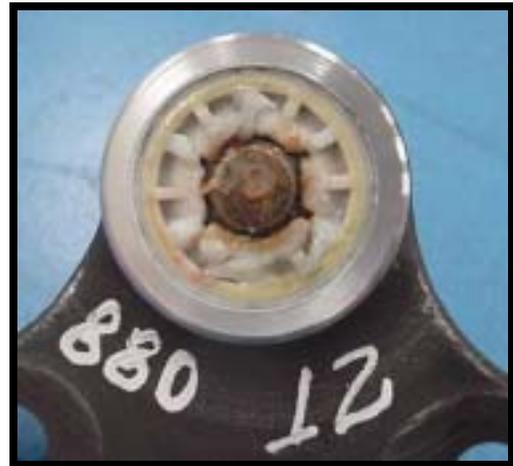
Figure 10: Lubricant A removed from test specimen 12

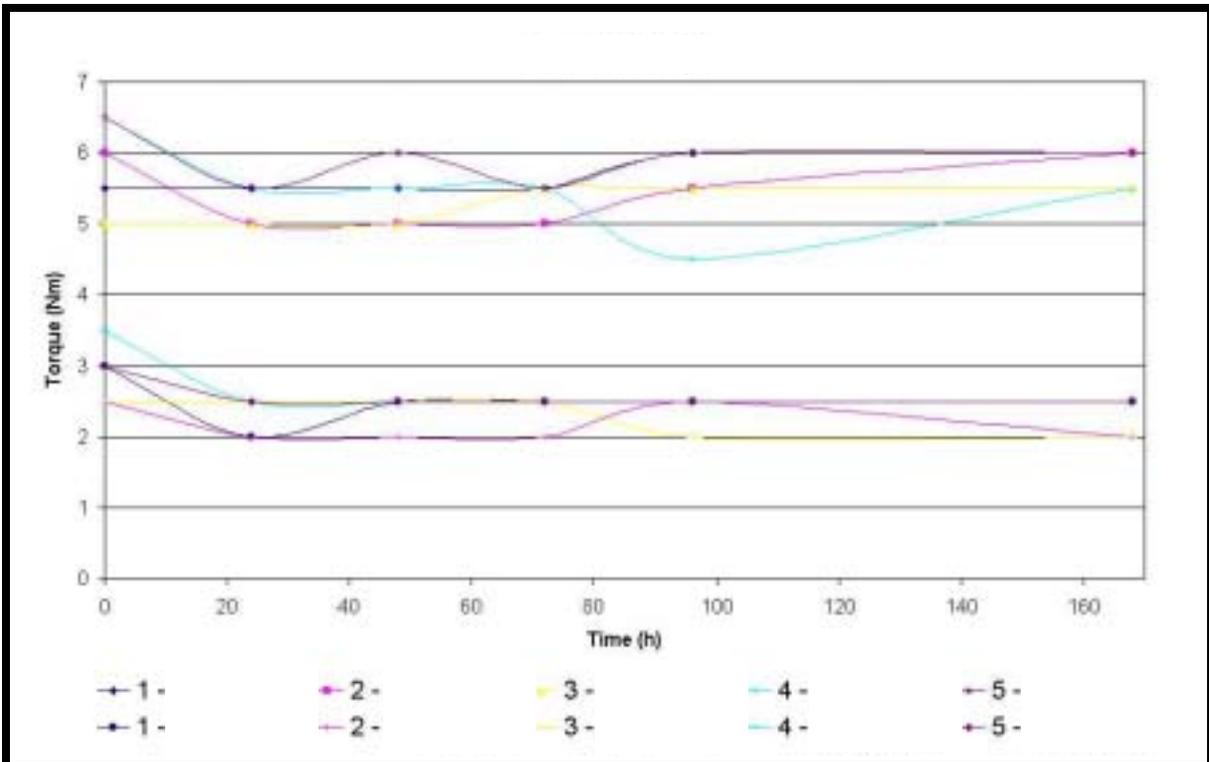
Figure 11: Lubricating system 2

Aspects verified in this study other than the elasticity values were the breakaway and movement torque values. The graph below displays the variation of torque values as a function of time.

Figure 11 displays the graph obtained from lubricating system 2 and Figure 12 displays the graph obtained from lubricating system 1. The higher values are breakaway torques and the lower values are movement torques.
